Pipe Bursting Keeps Cambridge, Mass., City Hall Running

BY RAYMOND HUTCHINSON AND DENNIS CARR, MWH, & JOHN J. STRUZZIERI, S.E.A. CONSULTANTS INC.

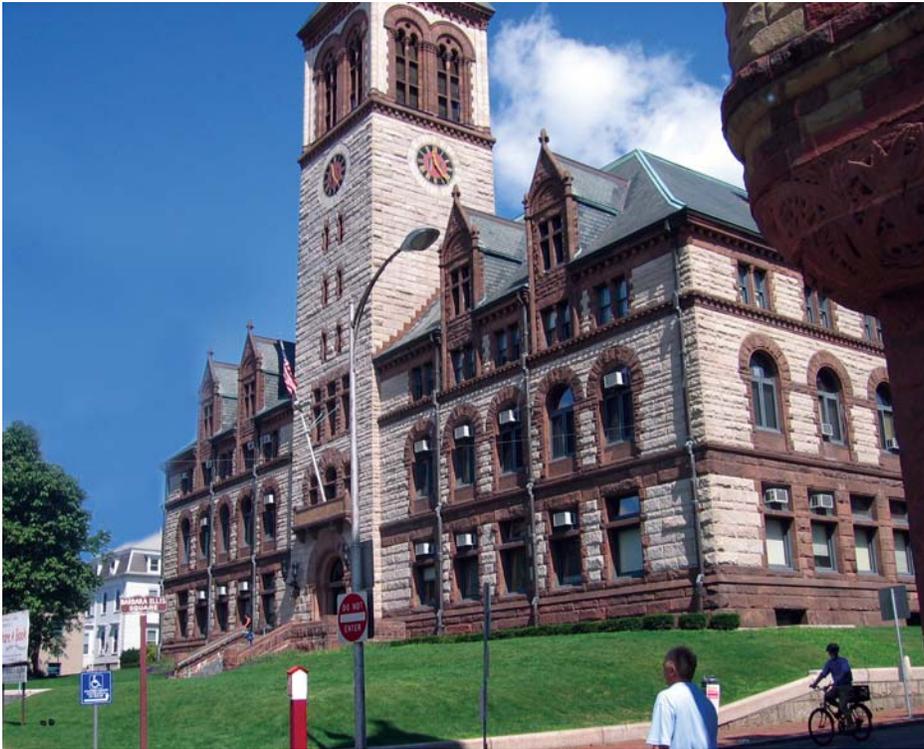
When it became necessary to replace an existing 8-in. diameter sewer under a 12-in. diameter drain in the front sidewalk of Cambridge City Hall, disruption was not an option.

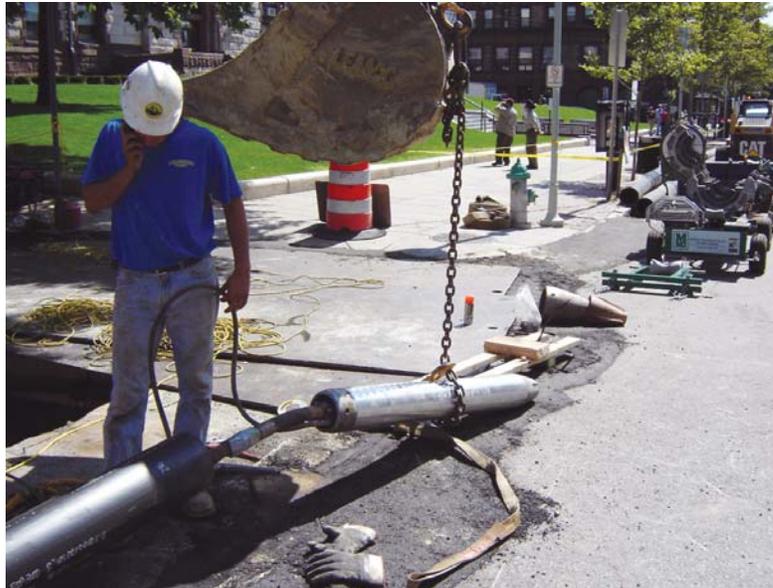
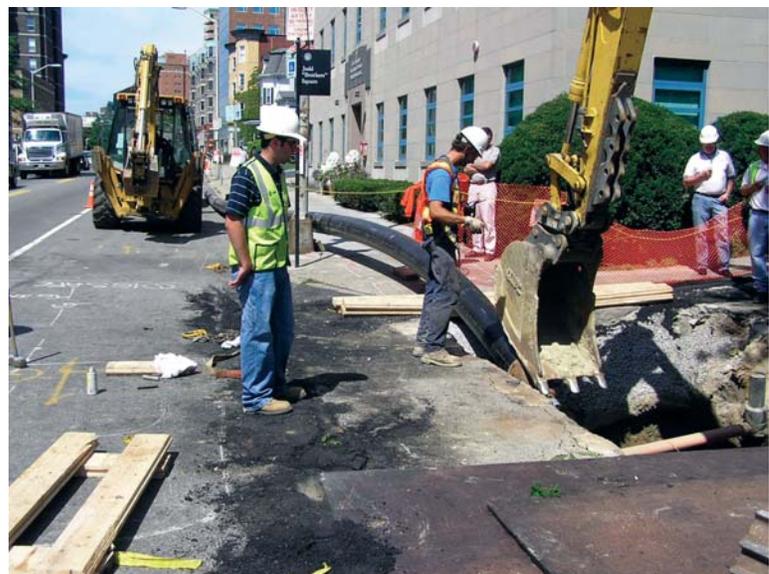
Discussions with the pipe bursting contractor prior to construction assured that a smaller access pit could be obtained by lifting and bending the pipe to increase the curvature of the pipe, without causing any damage.
